PAVED SHOULDER PROBLEM - STEVENSON EXPRESSWAY

A Phase of
Research Project IHR-6
Condition Survey of Route U.S. 66

July 1967

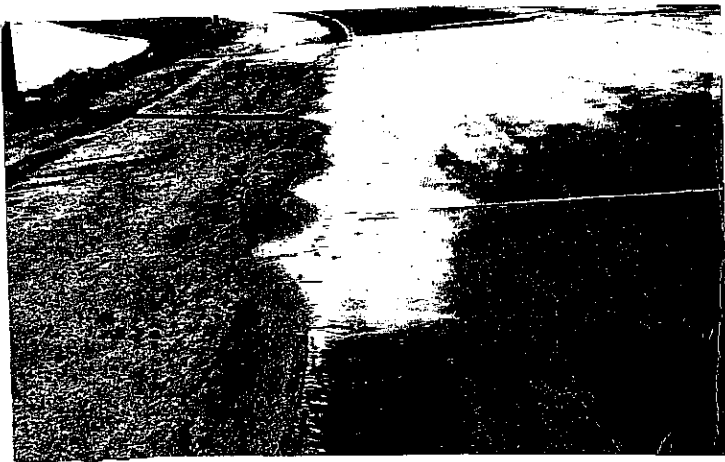
Photo 1. Severe area distress with water accumulation at shoulder-pavement interface.

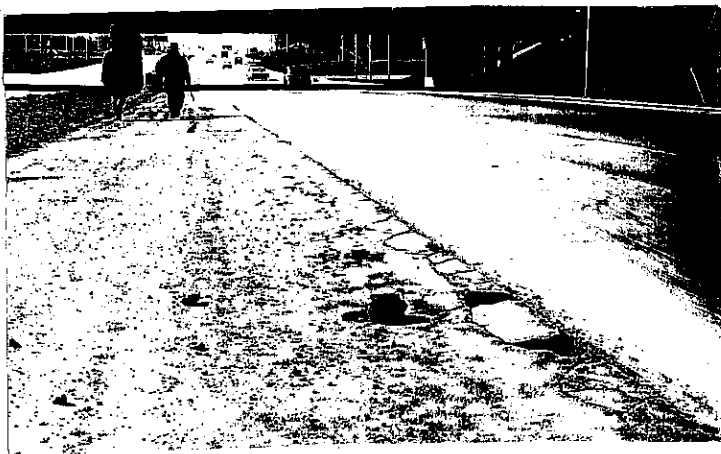
A wide range in area distress also will be noted between sections, without a significant difference between CAM and PAM base sections. Certain of the sections of both base types showed no area distress. The tendency toward area distress to be of greater magnitude in the outside shoulders is believed to be the result of greater usage of the outside shoulders by traffic. This type of distress, which it will be recalled was found to have occurred mostly near the pavement edge, is thought to be accelerated by traffic usage.

Photo 3. Typical area distress along median shoulders.

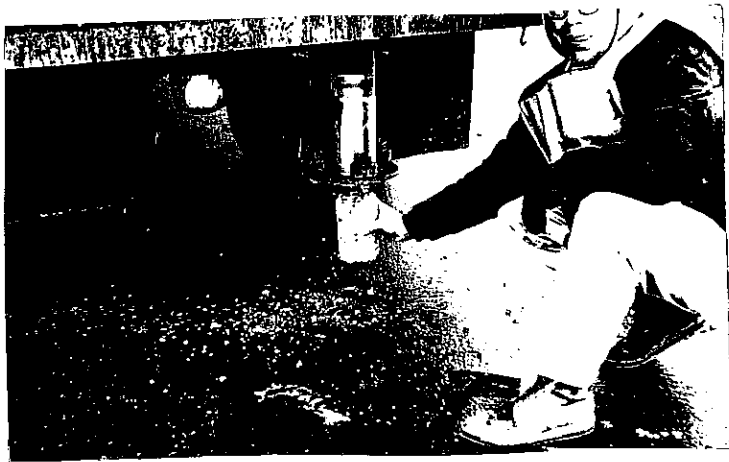
Photo 9. Successful coring attempt.

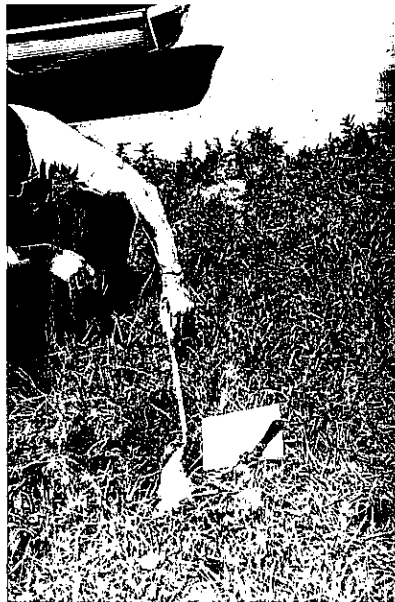
The subbase materials were found frequently to contain an excess of free water. Of 28 inspections of the subbase made during the square-cutting operation, it was found to be dry to moist at 5 locations, wet at 18 locations, and showing free water at 5 locations. During the course of these observations, it was noted that the topsoil and sod of the embankment slopes were often saturated with water at subbase elevation where full-width subbase was used and where the pavement grades were fairly flat.

Photo 13. Water draining from
subbase after sod
and topsoil removal.
